## **Catalytic Converter Failures**

If a catalytic converter needs replacing, one of the problems below most likely contributed to its failure.

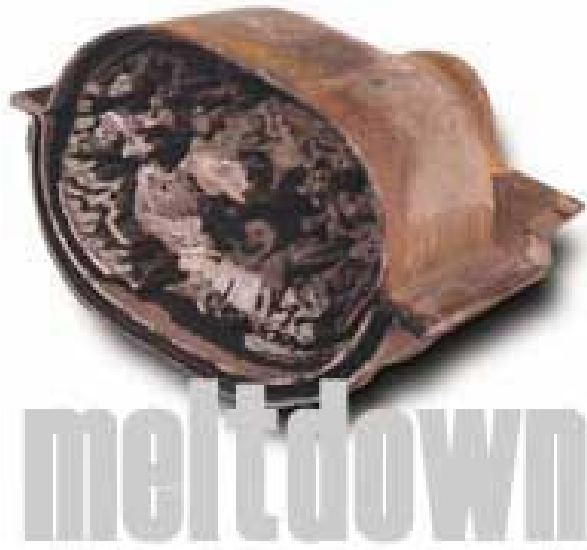
### **Converter Meltdown.**

This is an example of a converter meltdown. The converter was super-heated due to a raw fuel condition in the exhaust flow. The excess unburned fuel ignited when it struck the hot ceramic catalyst and drove the temperature far above the normal operating condition of the converter. The ceramic catalyst is unable to withstand the extremely high temperature and begins to melt. The ceramic collapses and the converter is destroyed. The melted ceramic may block the exhaust flow and cause additional damage to the engine. A converter glowing red-hot, or evidence of heat discoloration, confirms this situation.

The condition that led to this converter meltdown could be the result of a number of malfunctions including faulty oxygen sensor, an incorrect fuel mixture, worn spark plugs or plug wires, a faulty check valve, incorrect ignition timing, sticking float, faulty fuel injectors or other ignition malfunctions

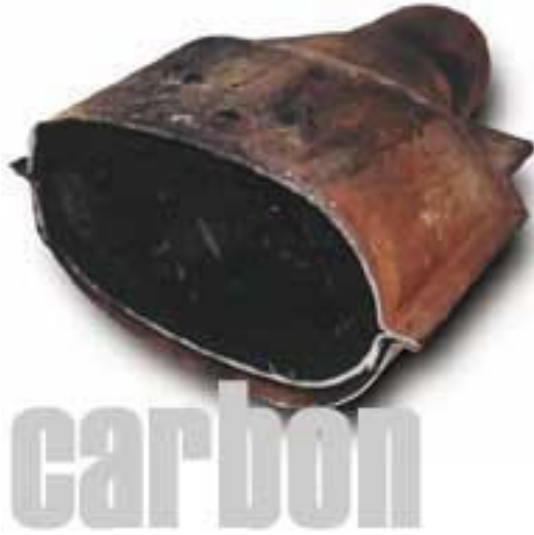
### **Carbon Deposits.**

This is an example of a converter with carbon deposits in the ceramic catalyst. This is usually a result of oil or antifreeze entering the exhaust system or a too-rich fuel mixture. The heavy carbon deposit clogs the converter and reduces exhaust flow. This increases backpressure and causes the entire exhaust system to heat up. The heat backs up into the engine compartment and may result in a number of heat-related engine problems.

Mild carbon scoring may do less damage to engine components but it may seriously affect the converter's ability to reduce harmful emissions. It could easily cause a vehicle to fail an emission test. Carbon deposits may be the result of faulty valves, worn piston rings, worn or leaking gaskets or lead in the fuel.

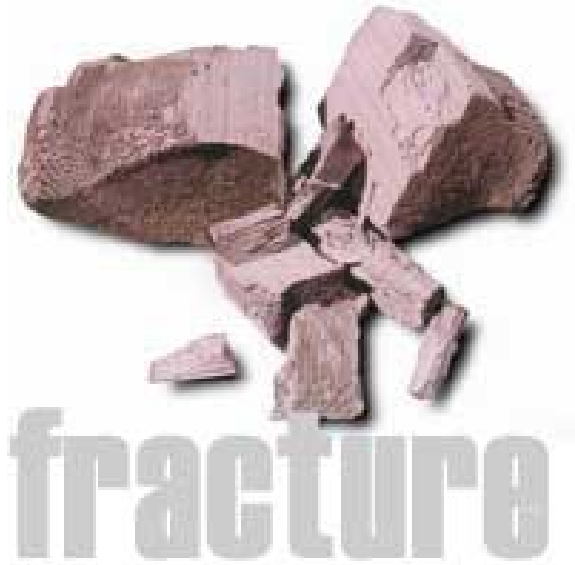
### **Catalyst Fracture.**

This is an example of a catalyst fracture. The ceramic became loose, cracked and began to break down. The pieces began to obstruct flow, creating backpressure and increasing the heat in the exhaust system. There is evidence of a partial meltdown in this example due to overheating.

The initial cause for this damage could have been road debris striking the converter based on evidence of impact on the converter shell. In some cases, if the protective mat that holds the catalyst in place is directly exposed to exhaust gasses, it could deteriorate and allow the catalyst to fracture. The Car Sound converter uses two recessed cavities in the body to hold the protective mat out of the exhaust flow to prevent any deterioration. The mat stays in place and the catalyst is held firm.
